TITLE: *Pavement Management: Key to Sustainable Concrete Pavement at the World's Busiest Airport*

AUTHOR(S): W. Charles Greer, Jr., Subash Reddy Kuchikulla, and James L. Drinkard

VENUE: *Proceedings, 10th International Conference on Concrete Pavements, Quebec 2012, Quebec City, Canada*

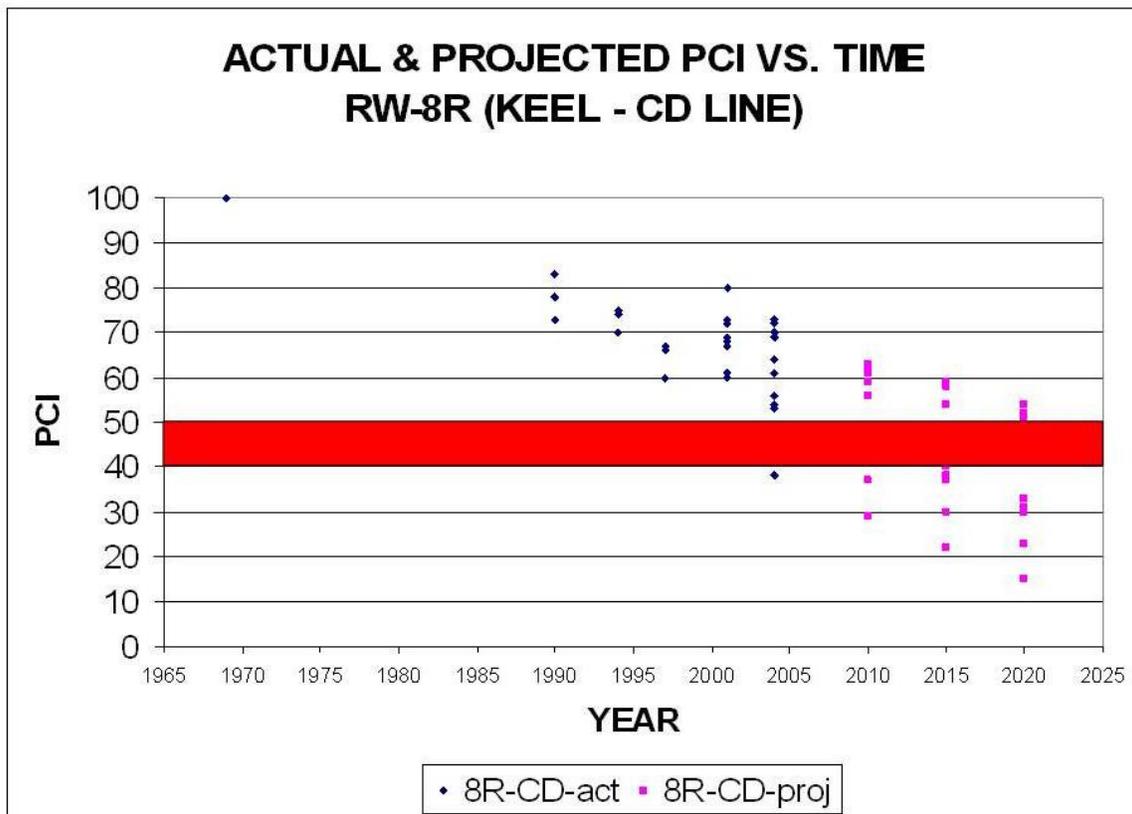
Figure 1 – Actual & Projected PCI vs. Time for RW-8R – 2004 Evaluation

been very useful in allowing objective assessments of the pavement conditions to be made along with estimates of when significant repairs, rehabilitation, or replacement should be planned. This objective process has been one of the key elements in determining that the useful service life of the concrete pavements at ATL could be extended well beyond their original design life. MicroPAVER was implemented in 2001 at ATL to allow a more automated approach for analyzing and managing the pavement data and predicting when critical condition indices might be reached. A typical PCI versus time curve is shown in Figure 1. This data indicated that the PCI values for RW-8R in the 2004 evaluation were approaching the level at which major rehabilitation or reconstruction would be necessary.

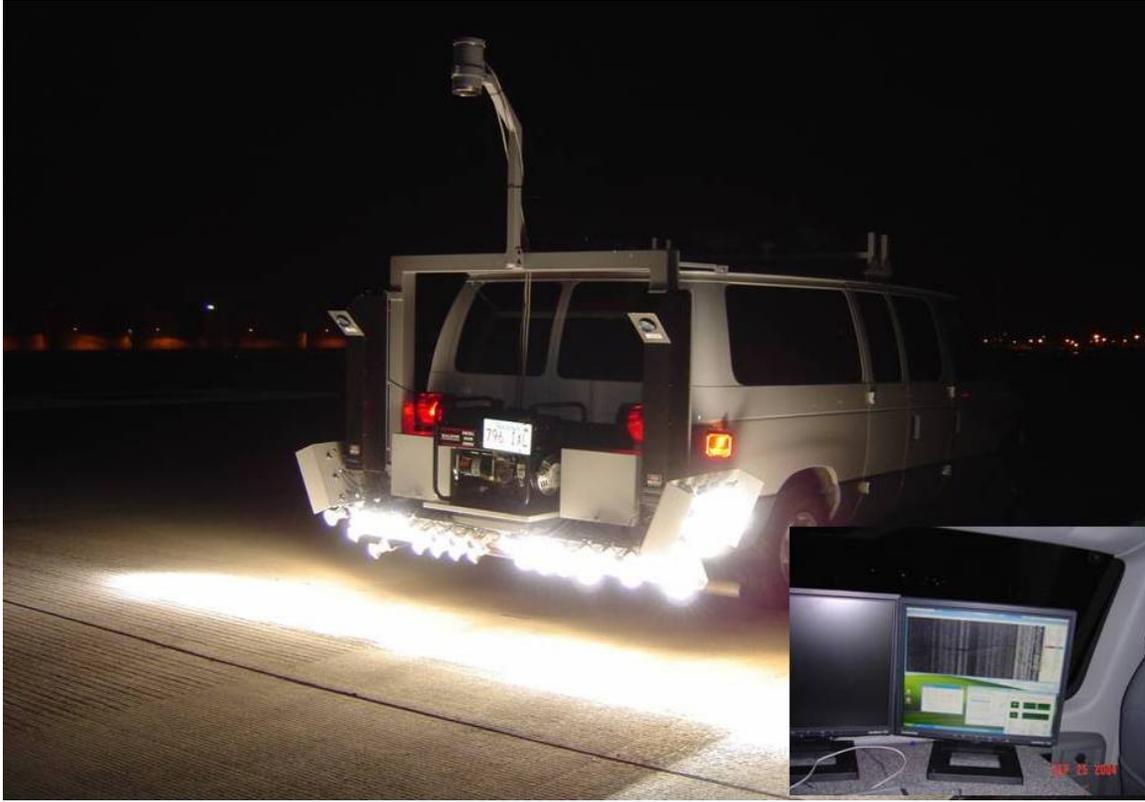
Figure 2 – Automated Digital Video Mapping Van and Recording Equipment

Automated Digital Video Mapping: The use of automated digital video imaging of the pavement surface was initiated in 2001 for RW-8R and RW-9L and extended to all four runways in 2004. It was used again in 2007 for RW-8L, RW-9L, RW-9R, and RW-10 (new 5th Runway completed in 2006). The data were collected at night with a van traveling at 40 to 60 mph with a scan width of 13 to 15 feet. This technology was used to supplement the walking surveys. Some defects observed in the walking surveys cannot be documented in the automated process. The van and equipment are shown in Figure 2. An entire runway can be mapped in 1 to 2 hours at night when operations are low.

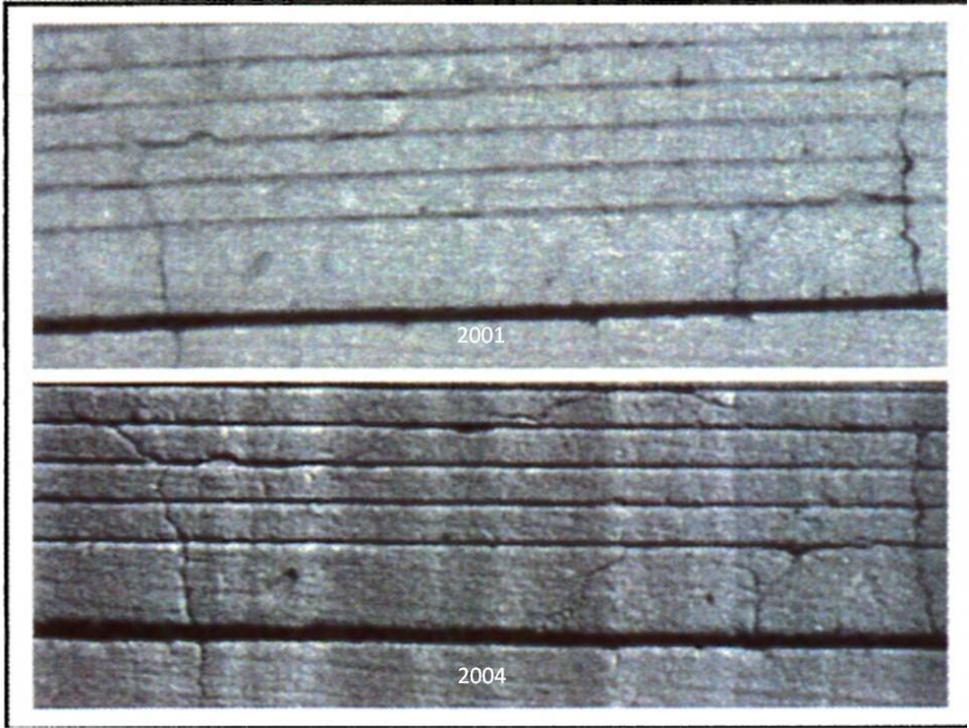
Figure 3 – Automated Video Mapping Output for a Location in 2001 and 2004

This technology allows the entire pavement surface condition to be documented and compared over several years in order to assess rates of deterioration. Distresses were also quantified using procedures similar to the Pavement Condition Index (PCI) process in MicroPAVER. Figure 3 shows the cracking distress at one location in 2001 and 2004. Figure 4 shows the cracking distress at another location in 2004 and 2007. These photographs indicate that there was very little change in the condition of the cracks over the three-year intervals. It is also evident that a wide range of crack width conditions can be documented with this technique. The authors have found that projecting the images on a large wall at large magnification makes it easier to see the “big picture” as opposed to the feeling that one is “looking at the pavement through a microscope”.

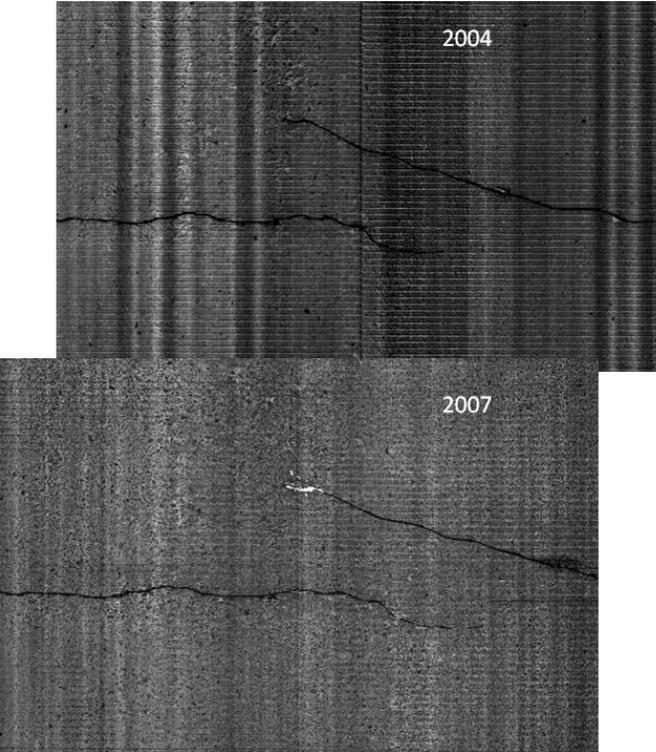
Figure 4 – Automated Video Mapping Output for a Location in 2004 and 2007

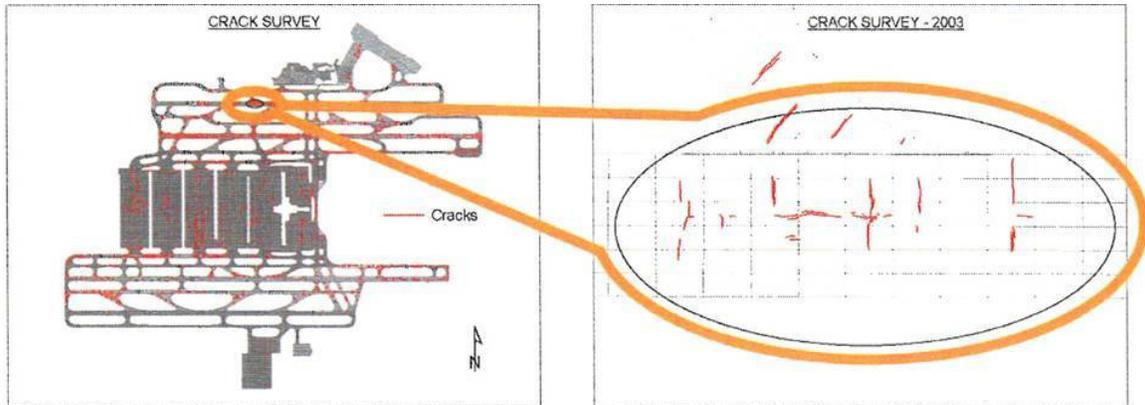
Figure 5 – Crack Survey Map with Detail for RW-8L Based on Database and GPS

Crack Surveys: In 1995, ATL began conducting detailed inspections intended to quantify cracks, spalls, and patches with ratings of good – fair – poor. The surveys have typically been conducted in the Fall of the year. They consist of a surveyor on foot with a GPS antenna and a steel dowel bar. The dowel bar is used to “sound” patches and joints for hollow sounds that could indicate cracks and delaminations. If a defect is found, the condition is documented as to severity and extent and the location is recorded with the GPS. A typical record of cracking for RW-8L is shown in Figure 5. These data are used to help establish periodic maintenance activities.

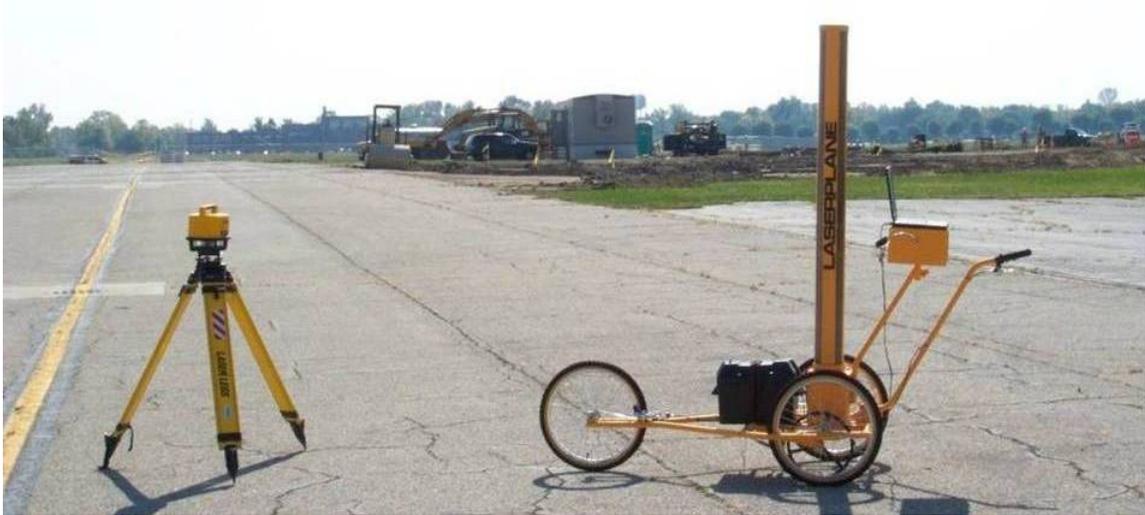
Figure 6 – Laser Source (left) and Cart System (right) for Profile Measurements

that utilizes a laser to radiate a plane of light and a cart system that has light sensitive cells on it (See Figure 6). Once the cart system has locked onto the laser, the cart is pushed along the longitudinal direction of the pavement and the system records the elevation of the cart every foot. The data are analyzed to determine the aircraft responses with proprietary software.

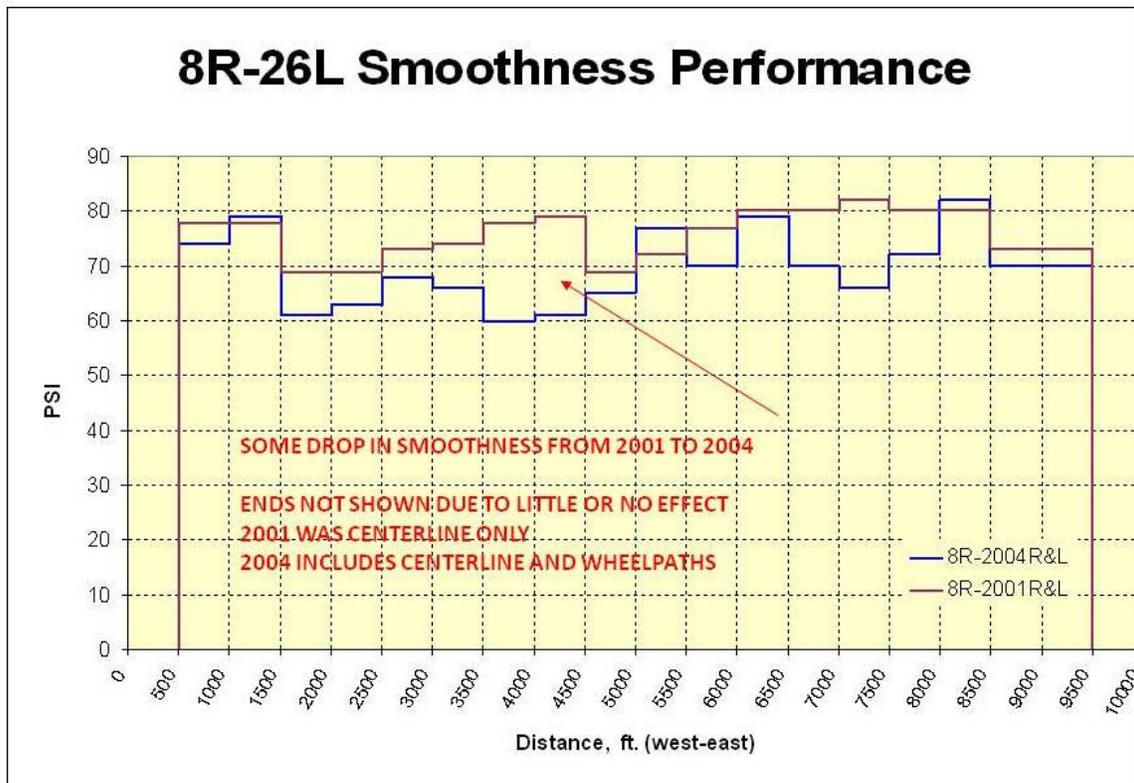
Figure 7 - Pavement Smoothness Index (PSI) versus Position, RW-8R, 2001 & 2004

The profile analysis output can be expressed as a Pavement Smoothness Index (PSI). Plots of PSI versus longitudinal position for RW-8R for 2001 and 2004 are shown in Figure 7. Changes in PSI with time can be monitored and aid in determining when to repair or replace a pavement due to excessive roughness. A pavement that is structurally very strong and exhibits little or no surface defects may be unacceptably rough. The runways at ATL have typically exhibited good smoothness.

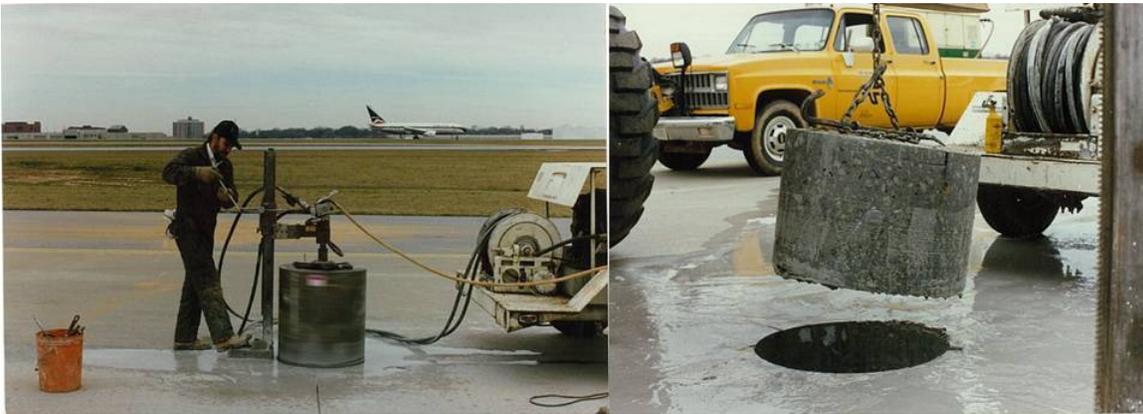
Figure 8 – Large 26-inch Diameter Core for Taxiway Cracking Investigation

Field Coring, Drilling, and Sampling: Coring of the concrete, cement treated base, and soil cement has been used in every evaluation except 1987. The subgrade soils were tested with standard soil test borings and undisturbed sampling. Test locations were generally located to investigate specific conditions observed in the visual surveys, particularly cracks, or anomalies noted in the FWD/HWD testing. The samples were returned to the laboratory for characterization tests. Occasionally it becomes necessary to do something out of the ordinary such as obtaining a large concrete core (26-inch diameter) in order to evaluate a problem such as corner cracking of concrete slabs on a taxiway. The investigation indicated that the slabs had curled and the corners were under the main gears of the aircraft.

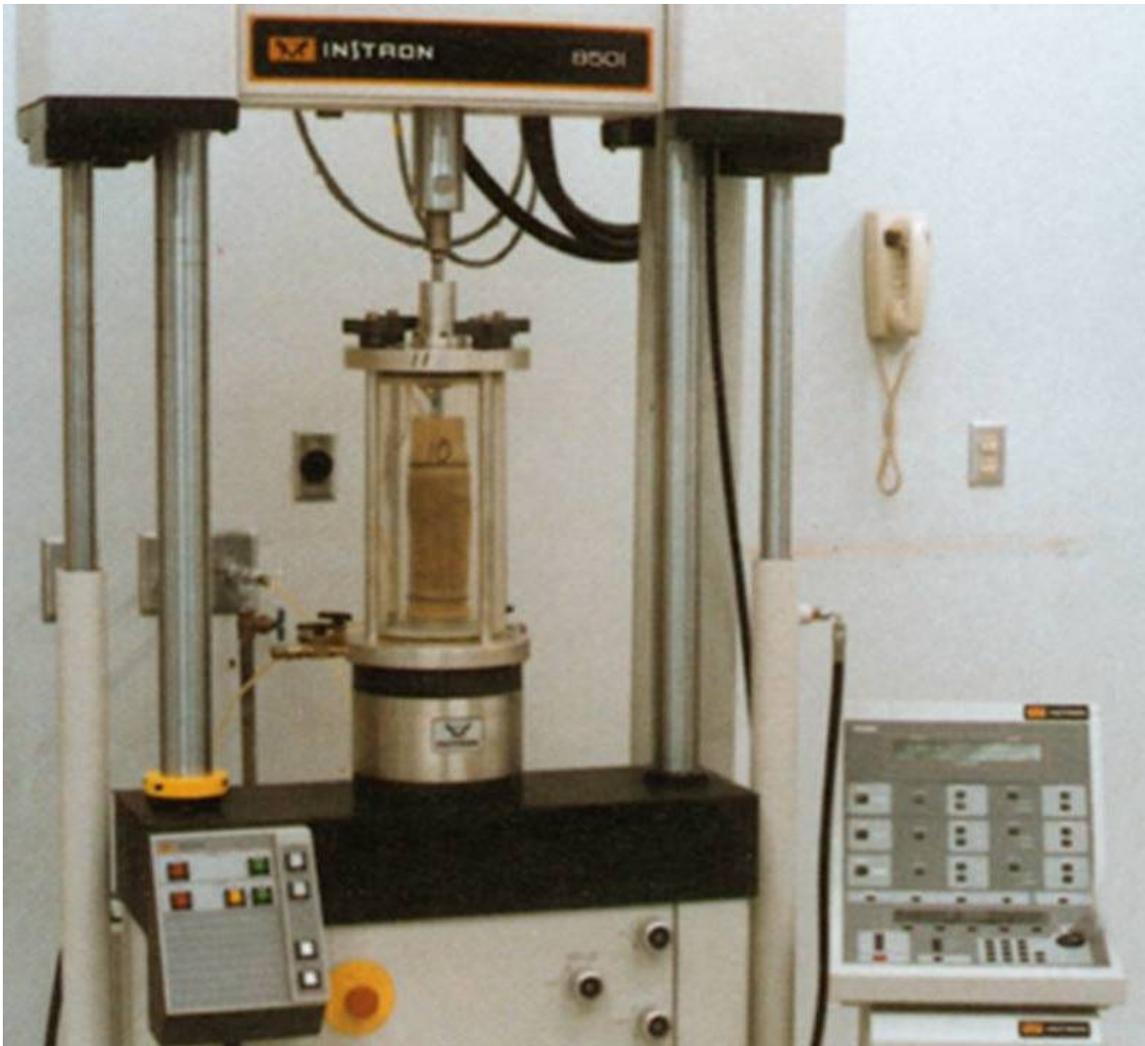
Figure 9 – Resilient Modulus Test Equipment for Subgrade Soil Characterization

Laboratory Testing: In the laboratory, strength and modulus of elasticity tests were performed on the cores of concrete, cement treated base, and the soil-cement. Split tensile strength tests were also performed on cores of the concrete. The results of these tests over the years have been correlated to quality control and quality acceptance tests performed during construction. The correlations have helped assure that the construction specifications are appropriate and have provided material relationships for evaluations of materials at the time of construction to determine their acceptability. The tests have been performed in every evaluation except 1987. Resilient modulus (E_r) tests on the undisturbed samples of the subgrade were first performed during the 1990 evaluation and in every evaluation since (See Figure 9). The E_r tests were used for layered elastic analyses of the pavements.

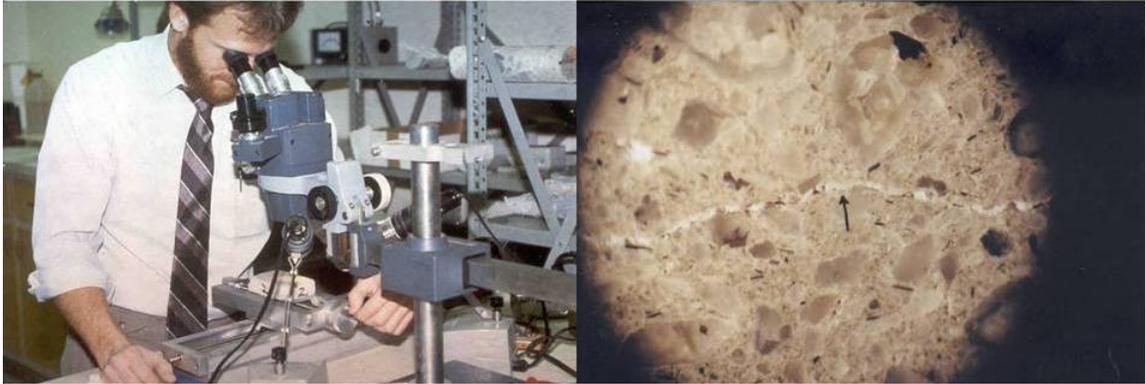
Figure 10 – Petrographic Examination of Concrete Core with Binocular Microscope

Petrographic Examinations: Cores of concrete not tested for strength were cut and polished to very smooth surfaces. They were examined petrographically with a binocular optical stereo-microscope at 10x-60x. This was done to observe the nature of cracks, assess the presence of reactions between the paste and aggregates, and evaluate secondary deposits in the air voids from ettringite formation. These procedures have been very useful in assessing the extent and severity of ASR issues in the concrete. Micro-photographs were taken of key conditions and observations. Figure 10 shows the microscope and condition in one of the cores with secondary deposits in a crack.

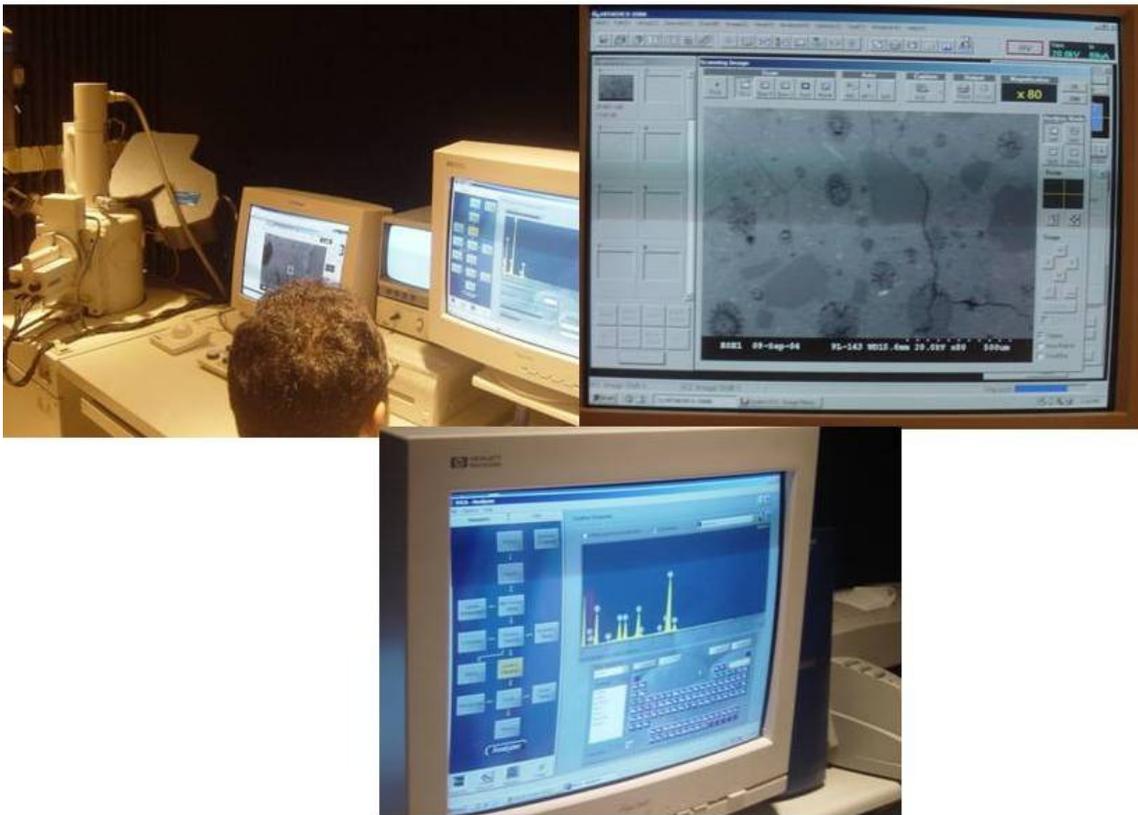
Figure 11 – SEM/EDX Equipment and Output for Concrete Core Analysis

Scanning Electron Microscopy and Energy Dispersive X-ray Analysis: In 2004, analyses of concrete cores with scanning electron microscopy (SEM) and energy dispersive x-ray (EDX) procedures were initiated. The SEM procedures were used to examine the polished surfaces of the concrete to assess the nature of cracks, voids, and reaction rims around the aggregates in the concrete. The EDX procedures were used to assess the chemical make-up of the surface including deposits in the cracks and voids. These analyses also allowed an in-depth assessment of the extent of ASR. Figure 11 shows the SEM/EDX equipment and output.

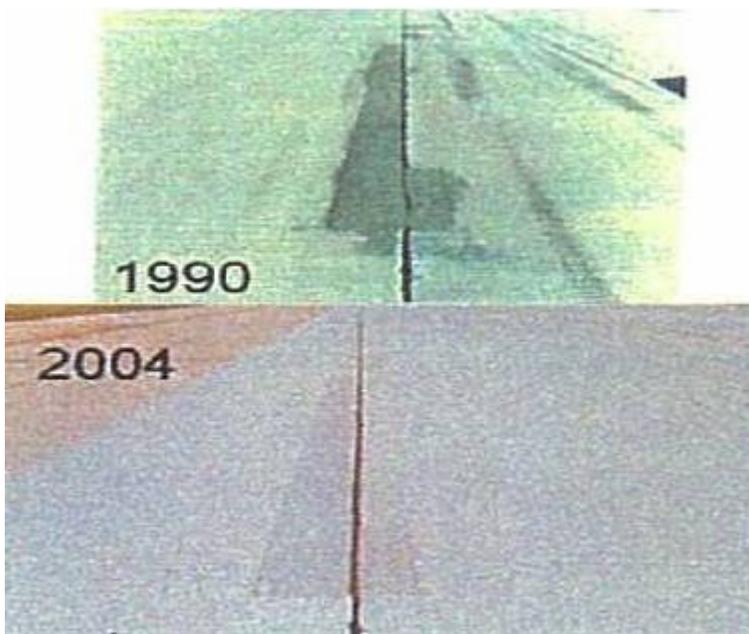
Figure 12 – Condition of Patch at Slabs 47B/C in RW-8R in 1990 and 2004

Figure 12 shows a patch for RW-8R in 1990 and again in 2004. Although the lighting effects and coloration are different in the two photographs, it is clear that the patch has performed very well during the 14-year time frame.

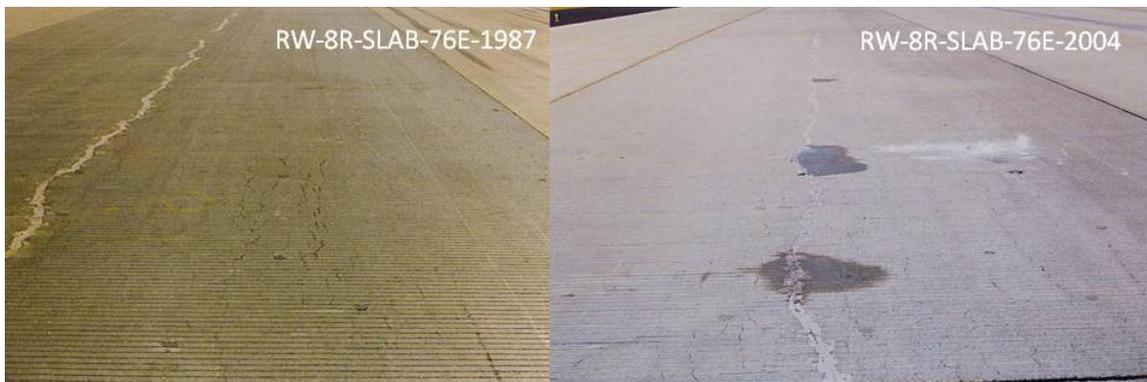
Figure 13 – Condition of Surface Cracking in RW-8R in 1987 and 2004

Figure 13 shows surface cracking in RW-8R in 1987 and again in 2004. Again the lighting and coloration are different, but the cracking and the crack repair did not greatly worsen over the 17 years between the photographs. The photographic history has been invaluable in supplementing the PCI data and the overall evaluation of deterioration rates.

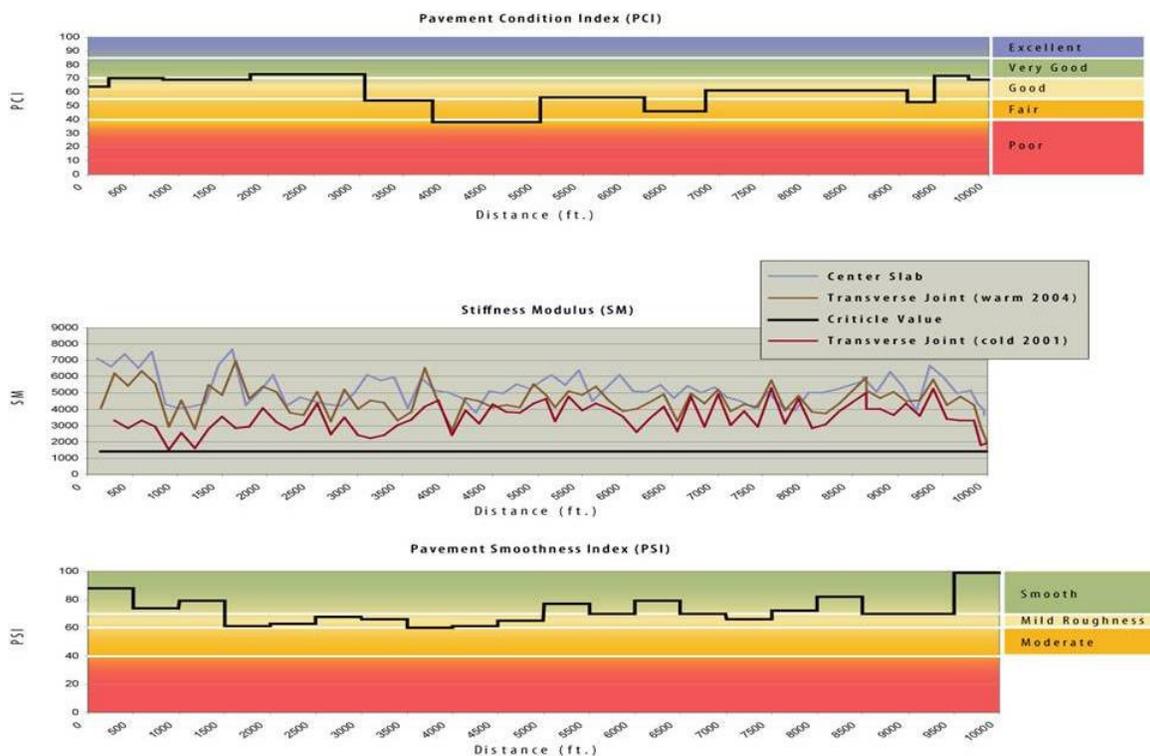
Figure 14 – Composite summary of the PCI, FWD Center-of-Slab Stiffness, and PSI for RW-8R for 2004 Evaluation

The PMS has been the most useful tool for providing sustainable concrete pavement at ATL. Figure 14 presents a composite summary from the 2004 evaluation. This summary allows one to visualize several condition/performance factors at one time. Distress in one parameter can be compared with other parameters for correlation. The extent of poor condition can also be seen. This summary picture can greatly aid in deciding that the life of concrete pavements can be extended. The PMS has also been a great investment for ATL; it has saved more than \$100 million in replacement costs over the years by allowing the airport to skip a whole generation of replacement for its 2 main departure runways.
